# RESEARCH MEMORANDUM

CYCLIC ENGINE TEST OF CAST VITALLIUM TURBINE BUCKETS - I

By J. Elmo Farmer, F. N. Darmara  
and Francis D. Poulson

February 19, 1948

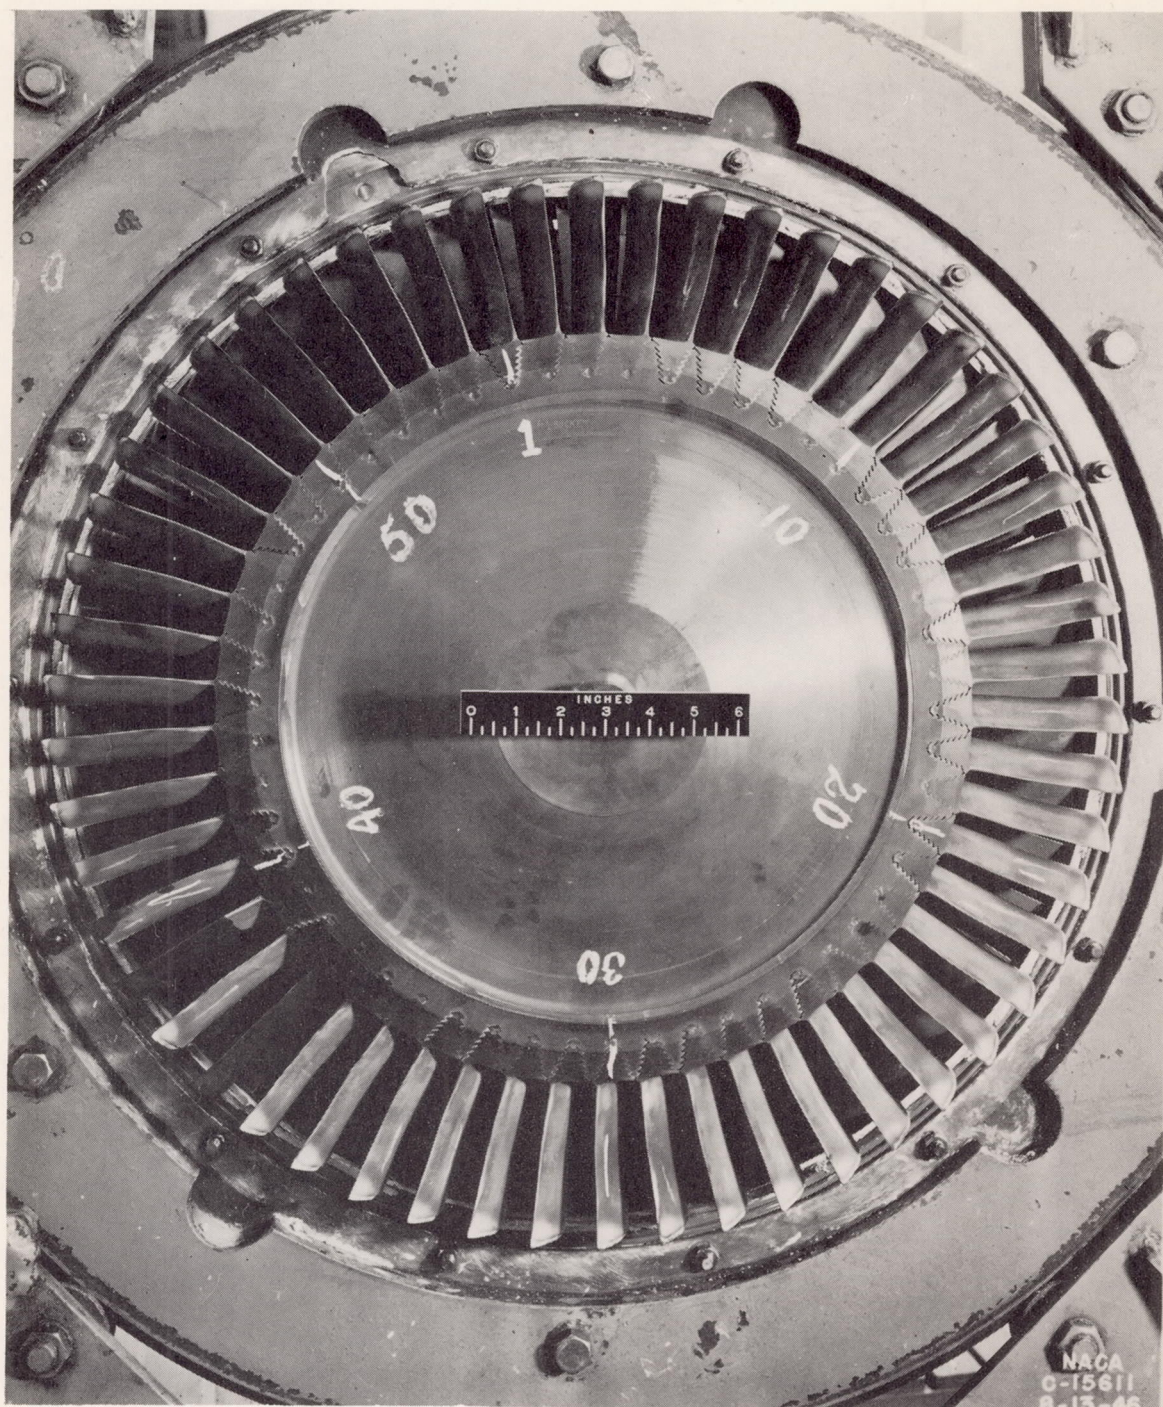
The turbine wheel was therefore removed, installed in another engine, and the running resumed. After cycle 229 (76 hr, 20 min total running time), the nozzle diaphragm was again found to be in bad condition and the engine was removed from the test cell for overhaul. No bucket failure had occurred. Many of the buckets had shifted in the axial direction, six of them sufficiently to rub on the gas baffle in the exhaust cone (fig. 11). Two buckets (buckets 3-16 and 3-43) were removed from wheel 3 for comparison with the broken buckets from the other wheels.

Figure 11. - Wheel 3 after a total running time of 76 hours and 20 minutes showing axial shift of buckets.

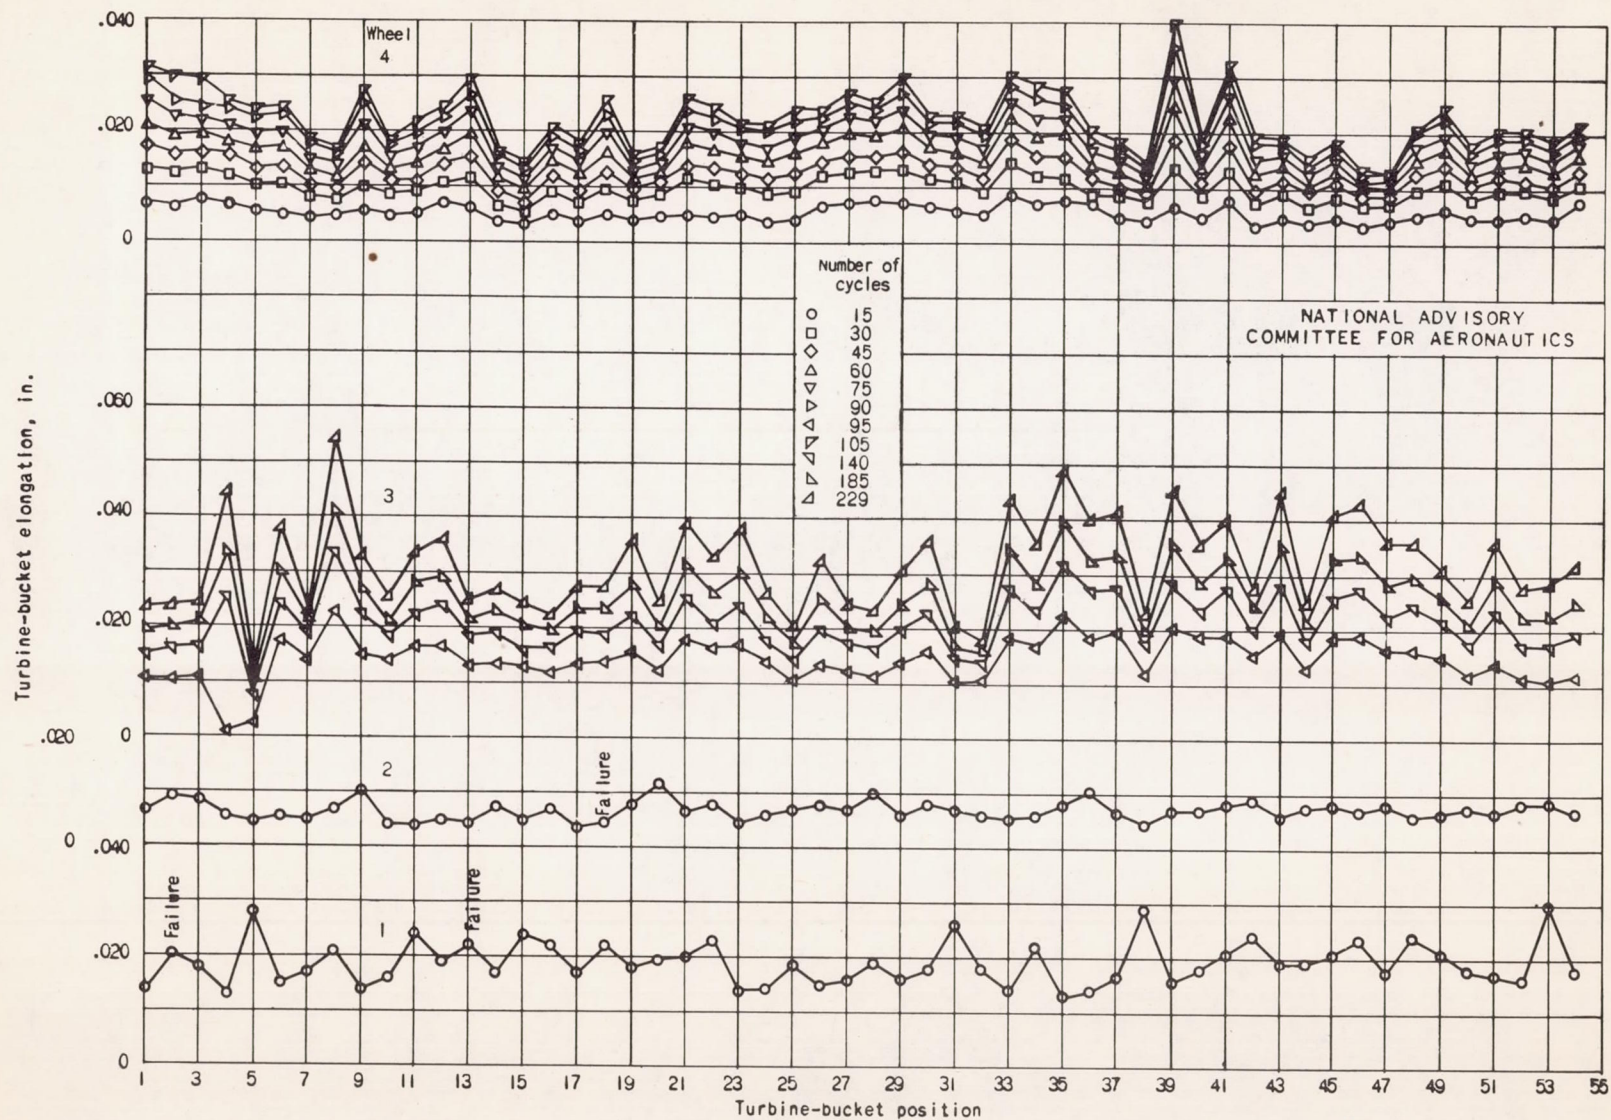
Turbine-bucket elongation. - The elongation of the turbine buckets for the four wheels is plotted in figure 12; the bucket failures are also indicated. The first bucket failures on wheels 1 and 2 so damaged the tips of all the other buckets that further measurements could not be made. The elongation data on wheels 3 and 4 are more complete; no bucket failures, however, have yet occurred on these wheels. All failures occurred at about the same distance from the bucket roots and the type of failure was the same in all cases (fig. 13).

Figure 12. - Variation of turbine-bucket elongation with time for four wheels investigated.

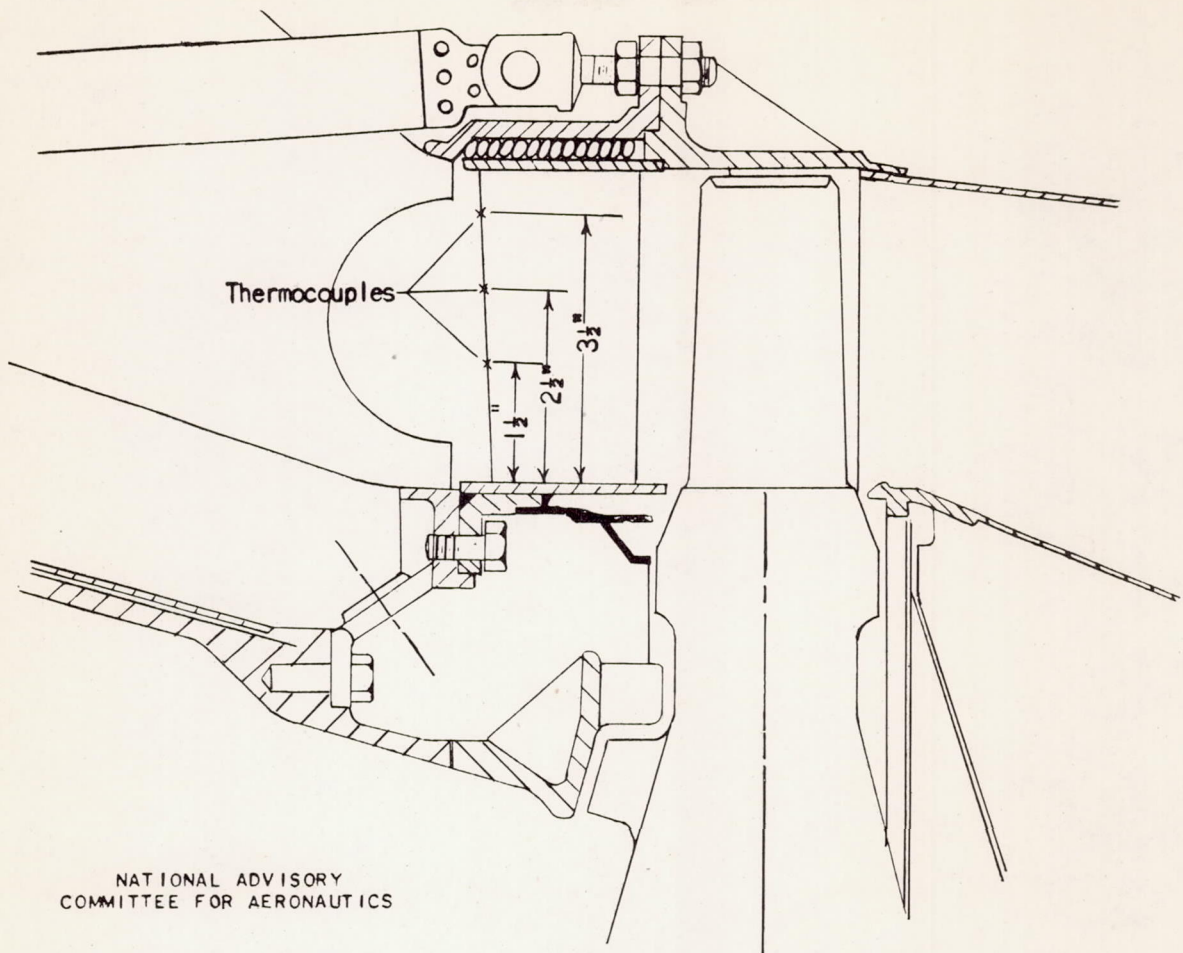
Nozzle-blade temperature. - The temperature variation along the leading edge of a turbine-nozzle blade located directly behind burner 1 is shown in figure 14. These temperatures were obtained by three chromel-alumel thermocouples located as shown in figure 14.

Figure 14. - Temperature variation along leading edge of turbine-nozzle blade on center line of burner 1 in turbojet engine at various rotor speeds.
